# VEHICLE INSPECTION REPORT

**SJ15TWE**

## Vauxhall Vivaro 2900 1.6CDTI 115PS

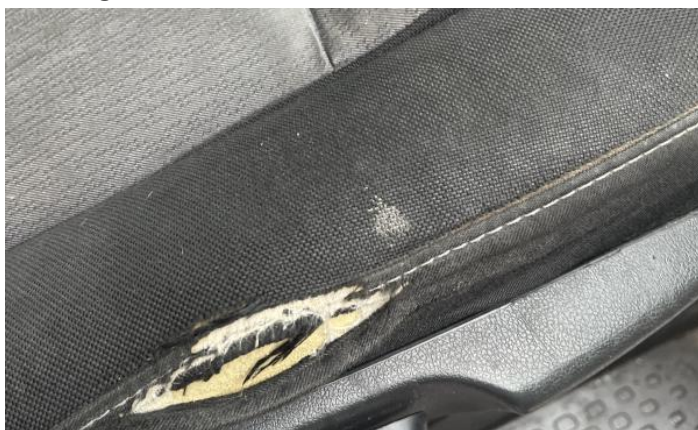
1: Seat Base Cover osf  
Torn  
Over 3mm

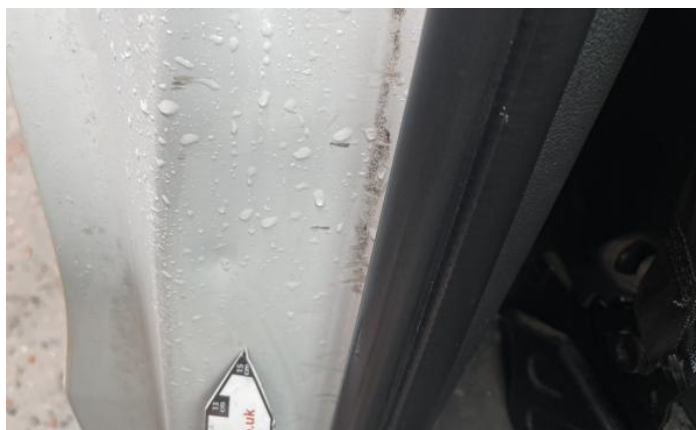
2: Sill os  
Dented  
Over 30mm

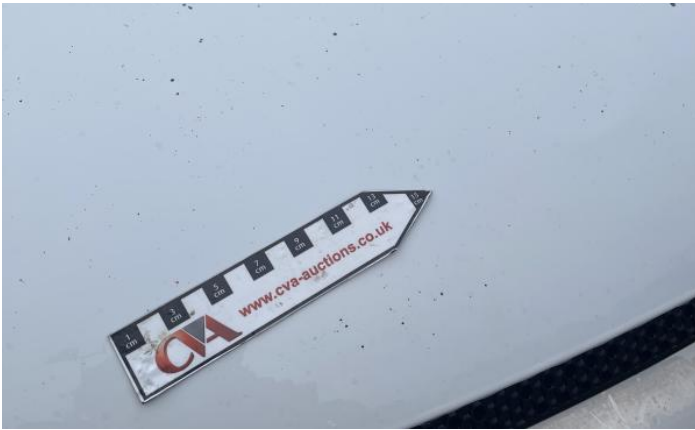
3: Bonnet  
Dented  
With Paint Damage

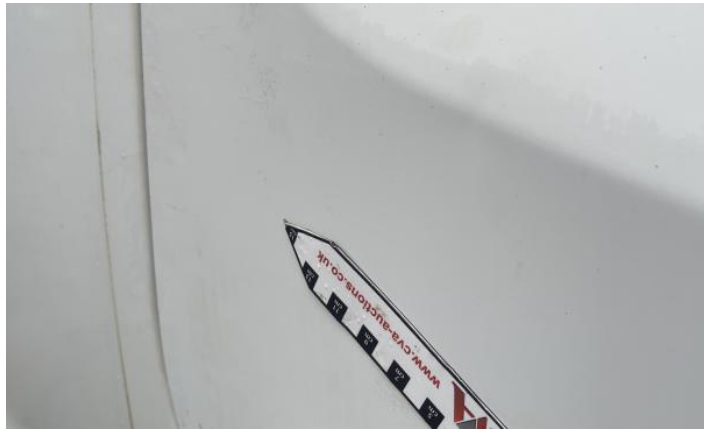
4: Door osf  
Dented  
With Paint Damage

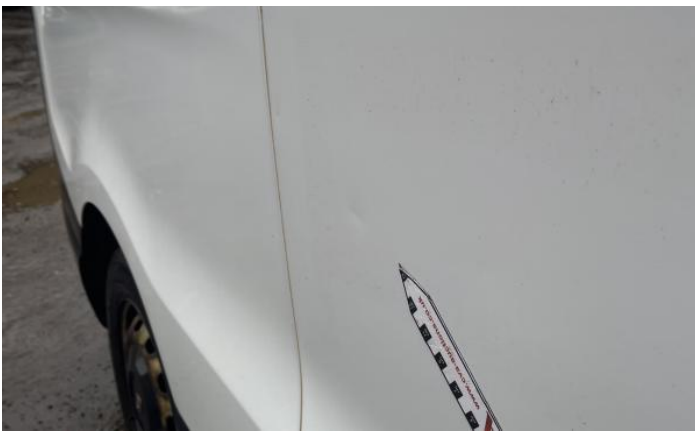
5: Qtr Panel osr  
Dented  
Over 30mm

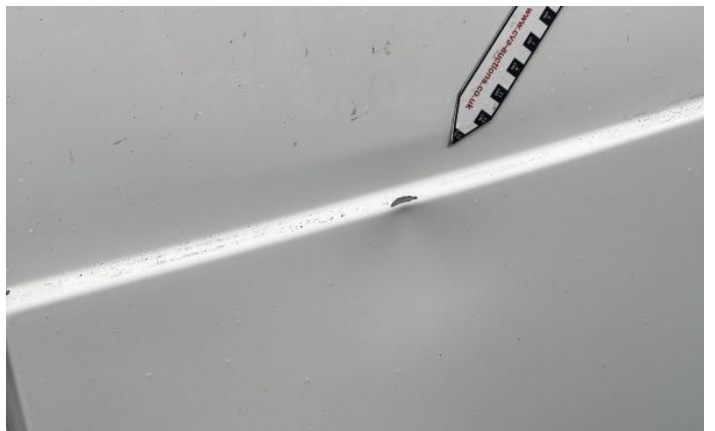
6: Tailgate  
Dented  
Over 30mm

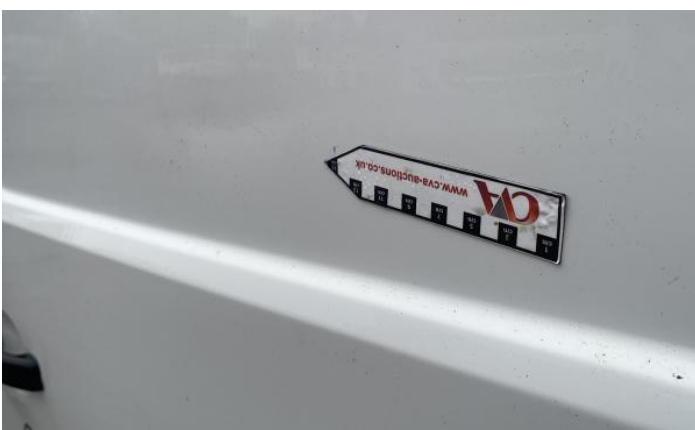
7: Door nsr  
Dented  
With Paint Damage

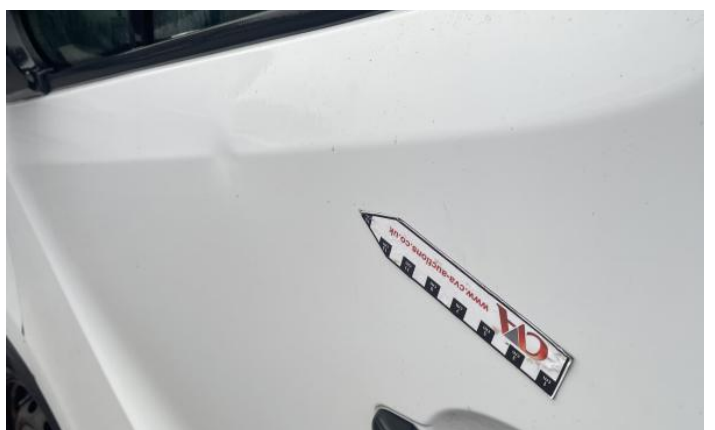
8: Door nsf  
Dented  
Over 30mm

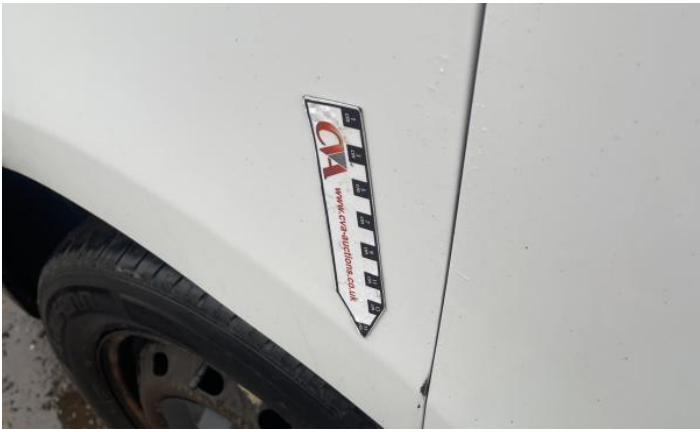
9: Wing nsf  
Dented  
With Paint Damage
