VEHICLE INSPECTION REPORT

YT16VHJ

Ford Transit Custom 290 2.2 TDCI 100PS

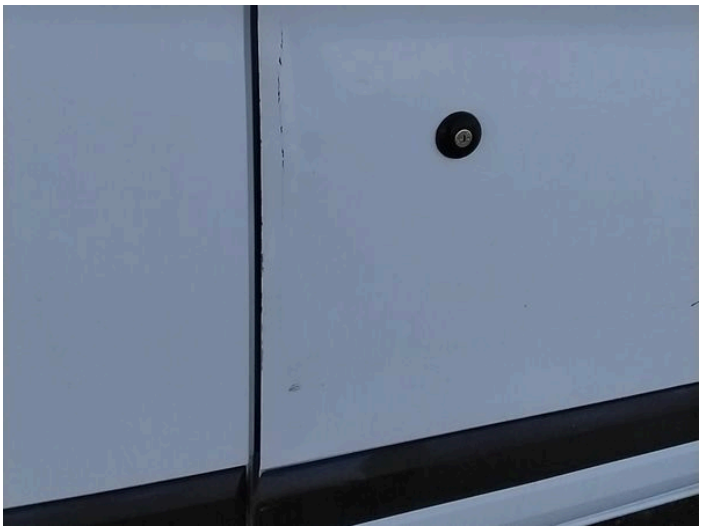
Damage Photos

1: A Post os
Chipped
1 To 5

2: Bonnet
Dented
With Paint Damage

3: Roof
Rusted
Over 5mm

4: Bumper Front Moulding
Scuffed (Unpainted)
UpTo 100mm

5: Door Mirror Assy nsf
Scuffed (Unpainted)
UpTo 100mm

6: Bumper Rear Moulding
Scuffed (Unpainted)
UpTo 100mm

7: Door osr
Scratched
UpTo 25mm Thru Paint

8: Door osf
Dented
With Paint Damage

9: Door osf
Scratched
UpTo 25mm Thru Paint

10: Seat Base Cover osf
Holed
Over 3mm
